F'IS Newsletter

January 2007

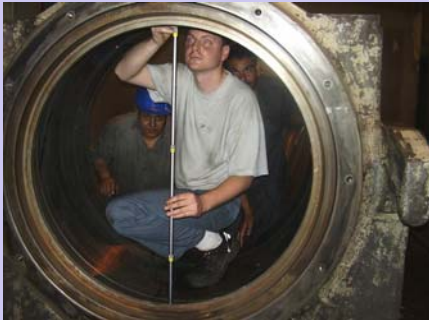
F'IS services: bearing replacement at aluminium rolling mill

Measuring the dimensions of bearing housings with a large diameter must be done with extreme care: That is why the operator of an aluminium rolling mill in Egypt enlisted the services of the F'IS experts when a four-row cylindrical roller bearing (outside diameter: 1168 mm) had to be replaced. The problem: the dimensional and form accuracy of the housing can change after some time in operation, for example as a result of wear and fretting corrosion. This would reduce the service life of a replacement bearing considerably. In this case, however, after the bearing seats had been checked thoroughly by the F'IS experts, the bearing could be mounted onto the shaft without problems. The customer now has the reassuring certainty that a proper bearing fit is ensured and that the replacement bearing's service life can be utilized fully.

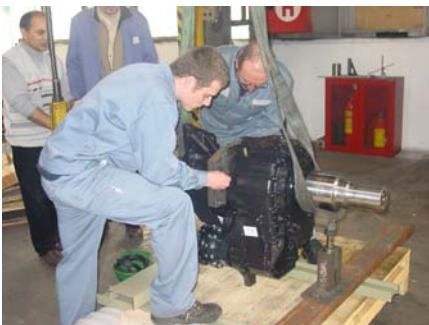
F'IS training: mounting of current collector bearings

The F'IS experts provide the accustomed premium service quality to customers all over the world. In this case, to a big manufacturer of wheelsets and wheelset spare parts in the Czech Republic. Apart from mounting a pair of current collector bearings, the F'IS experts were to show the customer's personnel how to mount the bearings. A briefing, which included a detailed specification of all individual steps as well as the provision and adaptation of the necessary tools, was followed by the hands-on part: The F'IS experts taught the customer's personnel how to mount the bearings properly so that they can carry out the batch mounting of the new unit on their own. Now that the customer's personnel has gained the qualification needed to perform the new task, the manufacturer will save the comparatively high mounting costs.
