F'IS Newsletter

September 2007

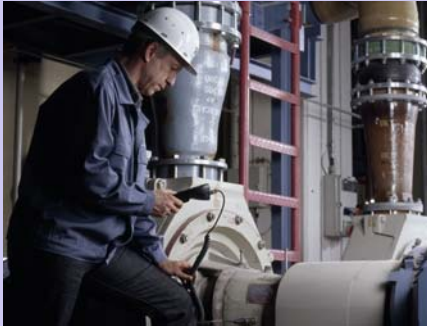
Balancing Work in Oil Tanker

A shipping company consulted the F'IS experts after two of their unloading pumps had failed. They carried out measurements with an FAG Detector III and detected imbalances of the fan impellers in two extraction fans. The imbalances were eliminated with the help of the FAG Detector III and the FAG Balancing Kit, and the unloading pumps were restored to working order. So the customer can now pump out the crude oil without delay, saving additional costs in the order of approx. € 300,000 per day. Moreover, they now have detailed information about the condition of the examined bearings.

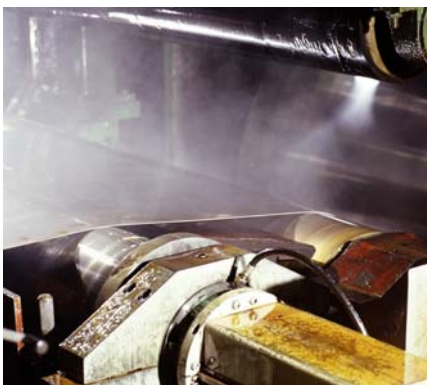
Detection of Bearing Damage at Roll Stand

When carrying out routine measurements on the drive train of a rolling stand in a steel mill, the F'IS experts detected signs of an inner ring damage in the frequency pattern for one of the bearings in the speed reducer. In order to be able to assess the severity of the damage more accurately, the bearing was also examined by means of endoscopy. The results showed that distinct wear had developed in the bearing which in turn had caused minor spalling in the raceway and in the rolling elements. As the damage had not yet progressed so far that the bearing has to be replaced, measurements are now being conducted at regular intervals. In this way, the customer can rest assured that the bearing's service life can be utilised as fully as possible and that the bearing will not cause any costly production disruptions (up to € 60,000/h).
